RELIABILITY ISSUES IN PV SYSTEMS – EXPERIENCE AND IMPROVEMENTS

H. Laukamp, K. Kiefer, R. Kaiser, H. Schmidt
Fraunhofer-Institut für Solare Energiesysteme ISE,
Oltmannsstr. 5, D-79100 Freiburg, Germany
Fax: ++49 761 45 88 217, e-mail: helau@ise.fhg.de

Abstract - A survey was conducted to collect information on faults, failures and poor performance from large PV plants as well as residential systems like the ones of the »1000-Roofs-Programme«. The reason for a low energy yield in some systems was analysed. Modern modules built for a high voltage show very few failures. In one plant electrical faults affected 0.1 % of the total number of modules after two years of operation. Of these failures 90 % took place in junction boxes. Main reasons for low yield of the »1000-Roofs-Programme« systems were over-rated power of modules, partial shading of the array, soiling, faulty connections on the dc side and inverter failures. Failure analysis leads to recommendations for improved junction boxes. Modern Class II components offer the system designers more liberties. It may be appropriate to dismiss string diodes and string fuses, which results in simpler and more reliable systems.

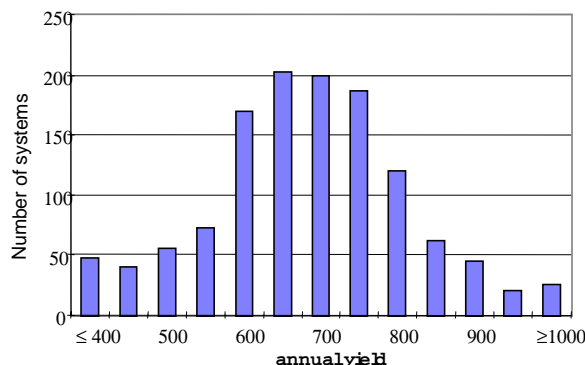
Looking at the annual yield of the systems shows an astonishing broad distribution (figure 1). This cannot be explained by the slightly uneven irradiation over Germany.

To understand the phenomenon a special investigation was conducted. A significant fraction of the poor performance was caused by prolonged inverter failures. Accounting for these systems still left some 100 systems with too low yield. Nearly all were inspected and 17 were analyzed in detail (Hoffmann

Fig. 1: Distribution of annual specific yield in 1996 (data from 1243 PV systems).

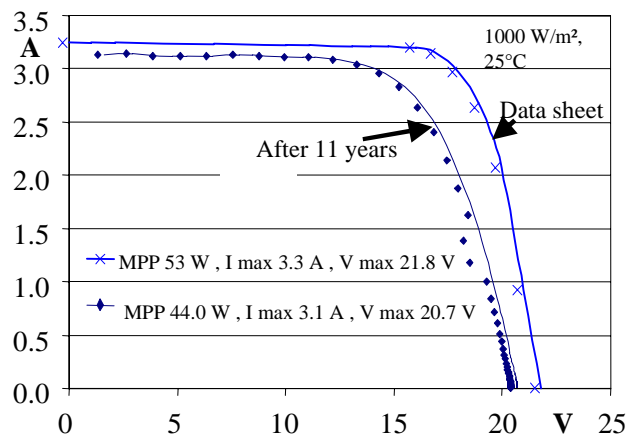
Rasmussen et al. (1999) report an interesting interaction of degradation, poor component specification and system design. An eleven years old system consists of strings of six modules ARCO M55 in series was retrofitted with a new inverter. The modules are degraded with reduced Voc (fig. 2).

Fig. 2: I-V curve of a degraded module after 11 years.

When the system was started with the new inverter a power drop at higher irradiance levels was noted. The analysis revealed that the inverter did not reach its specified minimum input voltage of 72 V but limited the input voltage at 85 V. Thus, the inverter was not able to track the MPP under the conditions of elevated module temperature and degraded Voc. System designers should allow for plenty of margin to account for such combined effects.

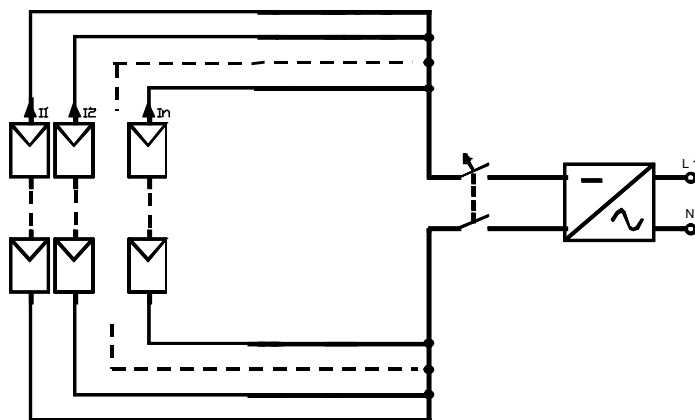
Not necessarily. Under certain conditions diodes and fuses may be omitted (fig. 3). This had been first appreciated in a german draft standard (Laukamp and Bopp, 1996). Currently an IEC (International Electrotechnical Commission) standard is under development using the same approach (IEC, 1999).

Fig. 3: Simple system design using class II equipment and double insulated wires with improved temperature rating

If the PV modules, all connection boxes and other equipment in the dc circuit and the inverter are rated Class II and if double insulated wires of high insulation rating are used than no additional overload protection is required. This method of wiring used to be called "earth fault- and short circuit proof".

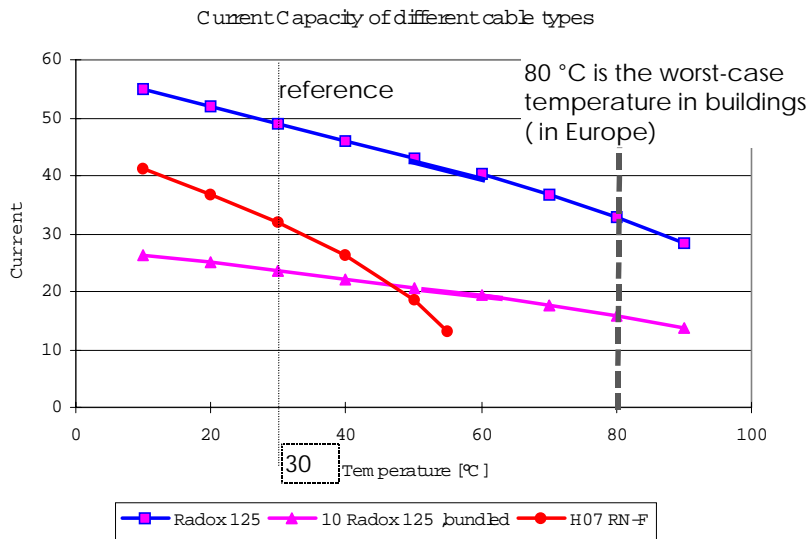
String diodes and fuses are not necessary, if the wires and the modules can carry the worst case fault current. The worst case current can be assumed to be $1.2 \cdot$ the short circuit current at STC of the whole PV generator. Critical is the temperature dependence of the cable used (fig. 4). There are new cables on the market with increased temperature resistance. These offer a huge advantage with respect to permissible currents at

elevated temperatures. Whereas regular cables rated up to 60 °C may not at all be used in a heat-insulated facade, modern cables offer a current capacity of several 10 A. (fig 4.). The »Radox 125« is just an example, other cables with similar properties are available from other manufacturers.

Fig. 4: Current capacity versus ambient temperature for single wires of different cable types and 10 wires of the Radox 125 type laid close together (bundling). Data were taken from DIN VDE 0298 Teil 4 and manufacturers data. For Radox 125 values below 30 °C were extrapolated. 30 °C is a standard reference temperature.

In smaller systems with up to 6 parallel strings of standard modules (In ca. 3 A), a wire of 2.5 mm² cross section and extended temperature rating (> 80°C) is sufficient, as it can carry all the generator short-circuit current.
